# **The Energetic Retrofit of Historic Masonry Buildings**

## **Focus on Central & Northern Europe**

In fulfillment of the M.S. Sustainable Design degree  
Carnegie Mellon University, Pittsburgh, PA

**Emil Alexandru Dinu Popa**  
**8/3/2010**

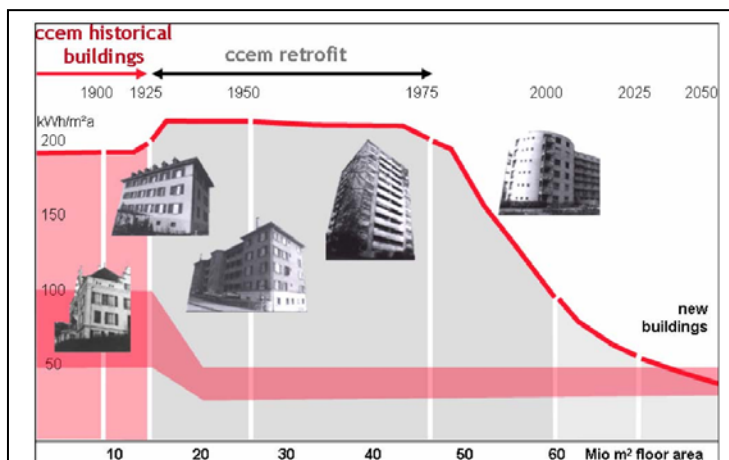
**Figure 2** Heating Energy Demand/ sqm. in the Canton of Zurich (CCEM, 2008)

eventual deterioration of the façade (CCEM, 2008). The same report mentions that, if all but the historic buildings were retrofitted, the older structures would amount to 60% of the heating energy consumption in the European building stock.

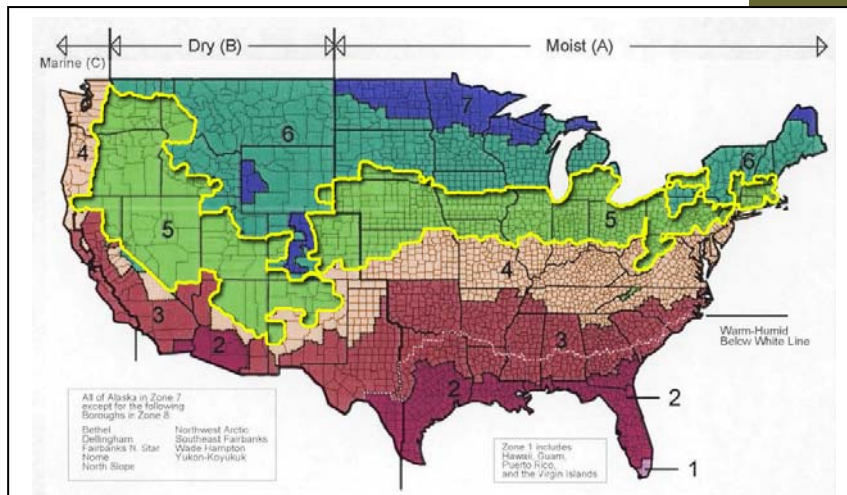
**Figure 8** Climate Zones of the United States - ASHRAE 189.1-2009

Due to the similarities in the weather patterns between the studied area of Europe and the U.S. climate zone 5, retrofit recommendations made within this report are also valid for similar constructions in the United States.

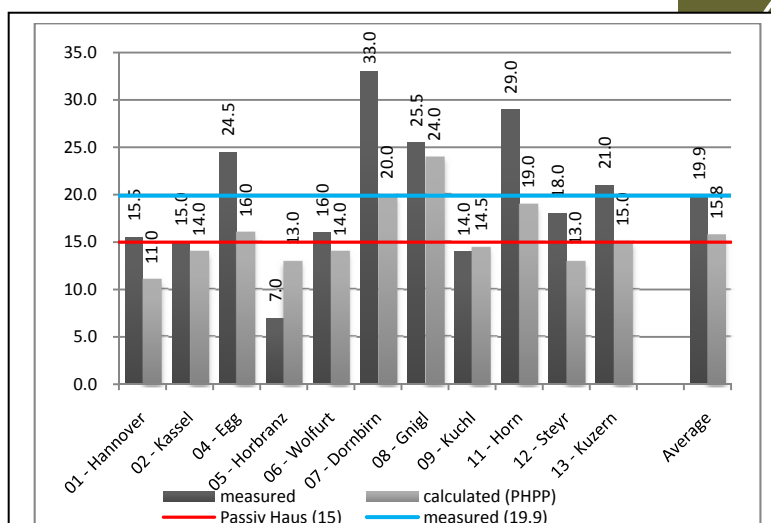
**Figure 15** Heating Energy Consumption for the CEPHEUS Project - Comparison of calculated and measured values

The difference between calculated values has been attributed to the user behavior (Schnieders, 2003) and to the fact that measurements were conducted primarily in the first year of operation, when the mass of the building had to be heated starting from a very low temperature. Feist indicates that 3-4 kWh/m<sup>2</sup>a can be lost due to the need to heat up the building mass following the construction period. In the case of user behavior the main issues are related to higher set point temperatures in the winter, traditional behavior of ventilation by opening the windows and failure to understand how the mechanical systems should be set up.

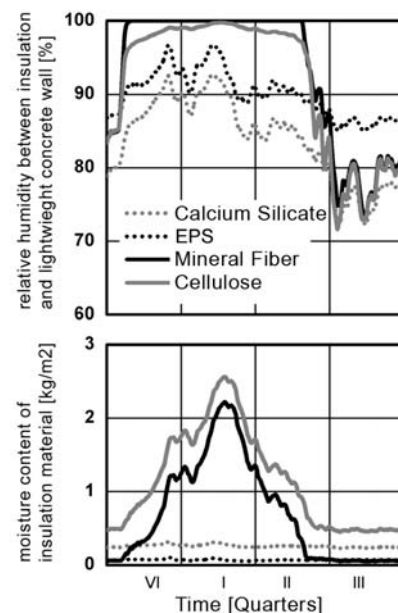
**Figure 16** Moisture decrease over the course of a year and the moisture content of different insulation materials over the same period when applied internally to a lightweight concrete block (Kunzel, 2004)

In the case of interior insulation, the masonry wall has a similar temperature to the outside, which, in the winter, makes condensation possible at the boundary between the solid wall and the interior insulation. Condensation occurs at this point, if moisture from the interior

Moisture from the room ambient may reach the wall surface through vapor diffusion through the insulation material itself or through convection at joining points between insulation panels or between the insulation layer and construction elements such as partition walls or slabs. In order to prevent convection, the insulation layer needs to be carefully constructed so that any possible gaps are removed. Often, interior walls have an uneven finish which can allow for hollow spaces between the wall and the panels, especially if rigid insulation materials are being used. Fiber insulation materials or leveling plasters are recommended in this case (Kunzel, 2004).

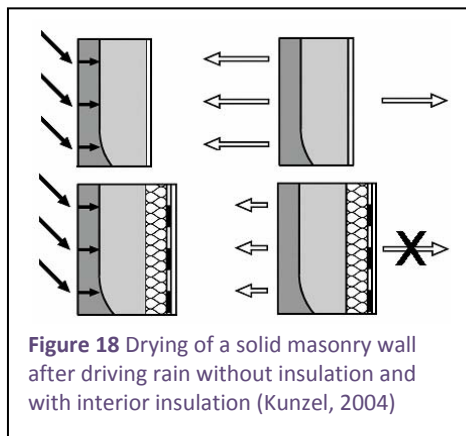
**Figure 18** Drying of a solid masonry wall after driving rain without insulation and with interior insulation (Kunzel, 2004)

An uninsulated exterior wall has the capability of releasing moisture both towards the exterior and towards the warm interior space, thus drying up. This process is especially facilitated during the summer months, when exterior temperatures are also sufficiently high. The moisture is released mainly through the exterior surface, as temperature rise in the summer season.

An exterior insulation layer made up from a non hygroscopic insulation material such as EPS forms a very effective barrier against driving rain. Even in the case of mineral fiber, experimental results have shown the wall has the capacity of drying out over the course of two years (Kunzel, 1998). The EPS protected wall dried up in twice the time it took the mineral wool protected one, the reason for that being the increased vapor permeability of mineral wool. Special care needs to be given to the selection of the external plaster because of the risk of moisture build up between the plaster layer and the insulation if there is a large difference between the vapor permeability of the plaster and the insulation material. A lower vapor permeability of the plaster can act as a barrier for moisture released through the insulation material, especially in the case of mineral wool. The main feature of the exterior insulation is, that it forms both a protective barrier against driving

By contrast, when applying insulation to the interior of a masonry wall, the temperature of the wall is reduced during the winter months, thus lowering the drying capacity of the wall towards the exterior. Although the drying capacity to the interior is lowered by the presence of the insulation material, the most effective way of preventing dangerous humidity levels within the wall is by controlling the surface rain water flow and preventing the wetting of the masonry. In this case, the application of an external hydrophobic treatment on the façade becomes necessary. This treatment should be applied some time before installing the interior insulation in order to allow sufficient time for the original wall to dry up (Kunzel, 1998).

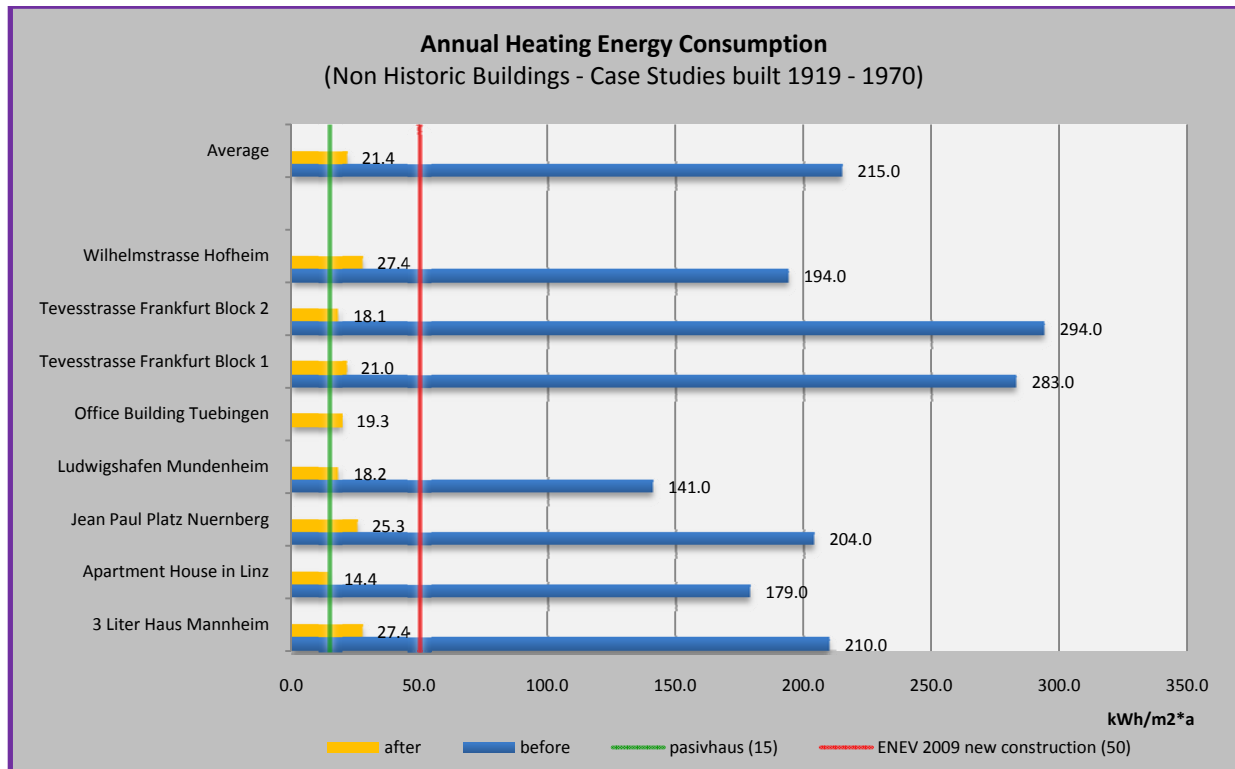
Figure 20 Annual Heating Energy Consumption – Non Historic Buildings - Case Studies built 1919 – 1970

The data from the analyzed buildings shows an average heating energy consumption before retrofit measures of 215 kWh/m<sup>2</sup>a. This high energy consumption is four times higher than the current German building codes (ENEV 2009) indicate as a maximum value for new residential construction. The poor performance of the buildings can be attributed mainly to the lack of insulation of the walls and slabs, insufficient or lacking insulation at roof level, poorly performing windows and window frames, and a high air leakage rate. The use of outdated and inefficient mechanical systems is also a reason for the high consumption values.

The average heating energy consumption for the retrofitted case buildings is 21.4 kWh/m<sup>2</sup>a, which represents a 90.5% reduction compared to the “before” value. Interventions included the upgrade of the envelope insulation capacity through additional insulation and the replacement of windows, the removal of the majority of leakage areas in order to obtain an air tight construction, the replacement of mechanical systems and the use of renewable energy, most notably solar thermal collectors (for hot water). This result is consistent with the findings of the CEPHEUS Study, which evaluated 200 newly constructed passive house units. The final report of that study indicated an 84% saving compared to the calculated potential consumption of the same building if it was built using conventional techniques (similar to those characteristic to the building stock) (Feist, et al., 2001).

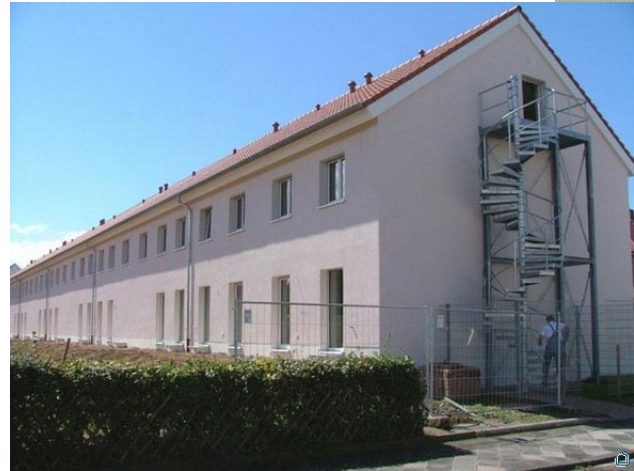
Figure 22 3 Liter Haus Mannheim - View after renovation

Location	Mannheim / Germany	
Location Type	suburb	
HDD	5,090	
CDD	666	
Year of Construction	1931	
Year of Retrofit	2004	
Historic Preservation	none	
Building Use / Type	residential / detached	
Orientation	NE-SW	
No. of Floors	before	after
	2	2
Cond. Usable Area (m <sup>2</sup> )	1,150	1,150
Construct. Cost (€/m <sup>2</sup> )		2,300

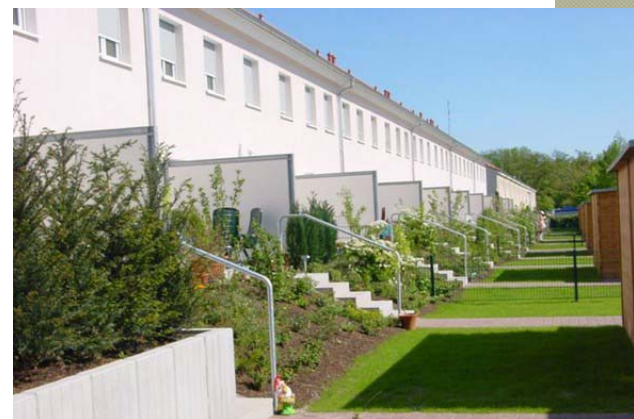
Figure 21 3 Liter Haus Mannheim - back facade after renovation

before	after
Walls – Main Facade	1.280	0.150
Walls – Gable	1.280	0.120
Roof	0.940	0.110
Floor / Slab	1.370	0.110
Windows	2.60	0.80
Infiltration Rate (ACH at n50)	4.2	1.2

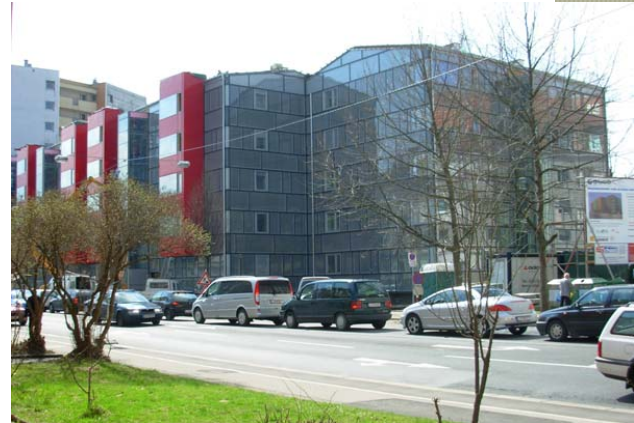
Figure 24 Apartment House in Linz - view after retrofit

Location	Linz / Austria	
Location Type	inner city	
HDD	6,271	
CDD	450	
Year of Construction	1957	
Year of Retrofit	after 2000	
Historic Preservation	none	
Building Use / Type	residential / attach. 1 side	
Orientation	E-W	
No. of Floors	before	after
	5	5
Cond. Usable Area (m <sup>2</sup> )	2,755	3,106
Construct. Cost (€/m <sup>2</sup> )

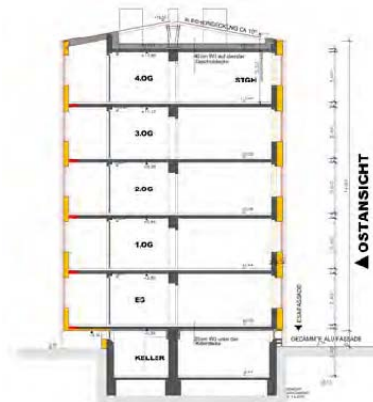
Figure 23 Apartment House in Linz – section after retrofit

before	after
Walls	1.200	0.082
Roof	0.900	0.093
Floor / Slab	0.700	0.205
Windows	3.00	0.86
Infiltration Rate (ACH at n50)		0.60

type	location	thickness (mm)	conductivity (W/mK)
Walls	Mineral Wool + Honey Comb	exterior	190 + 50	0.040
Roof	Mineral Wool	exterior	400	0.040
Floor / Slab	Mineral Wool + Porit	exterior	100 + 50	0.035 / 0.040
Windows	triple	replacement	PVC insulated

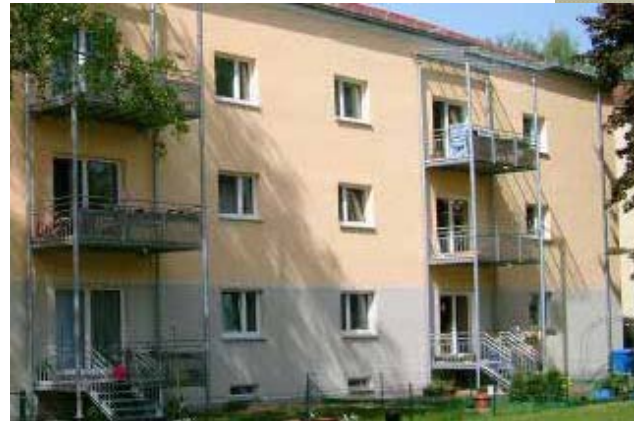
Figure 26 Jean Paul Platz Nuernberg – View after Retrofit

Location	Nürnberg / Germany	
Location Type	suburb	
HDD	6,325	
CDD	406	
Year of Construction	1930	
Year of Retrofit	2002	
Historic Preservation	none	
Building Use / Type	residential / detached	
Orientation	N-S	
No. of Floors	before	after
	3	3
Cond. Usable Area (m <sup>2</sup> )	894	894
Construct. Cost (€/m <sup>2</sup> )		540

before	after
Walls	1.447	0.156
Roof	0.870	0.120
Floor / Slab	0.880	0.190
Windows		0.80
Infiltration Rate (ACH at n50)	4.9	0.35

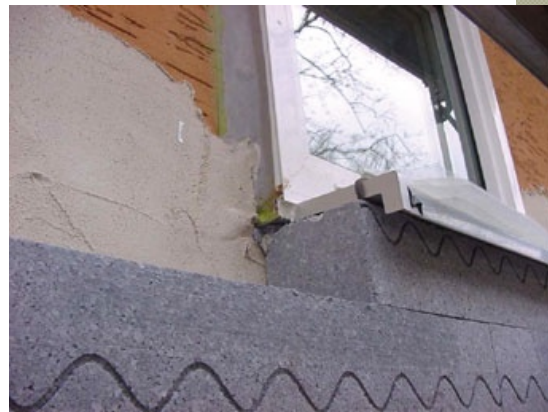
Figure 25 Jean Paul Platz – wall insulation

type	location	thickness (mm)	conductivity (W/mK)
Walls	EPS (Neopor)	exterior	200	0.035
Roof	EPS (Neopor)	exterior	250	0.035
Floor / Slab	EPS (Neopor)	exterior	140	0.035
Windows	triple	replacement	PVC insulated

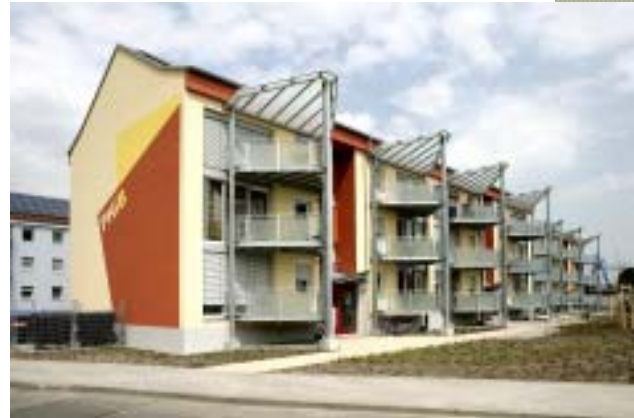
Figure 28 Ludwigshafen Mundenheim - View after retrofit

Location	Ludwigshafen / Germany	
Location Type	suburb	
HDD	5,090	
CDD	666	
Year of Construction	1965	
Year of Retrofit	2005 – 2006	
Historic Preservation	none	
Building Use / Type	residential / attach. 1 side	
Orientation	N-S	
No. of Floors	before	after
	3	3
Cond. Usable Area (m <sup>2</sup> )	750	750
Construct. Cost (€/m <sup>2</sup> )		1,177

before	after
Walls	1.294	0.100
Roof	0.516	0.114
Floor / Slab	0.640	0.170
Windows	2.8	0.83
Infiltration Rate (ACH at n50)		0.46

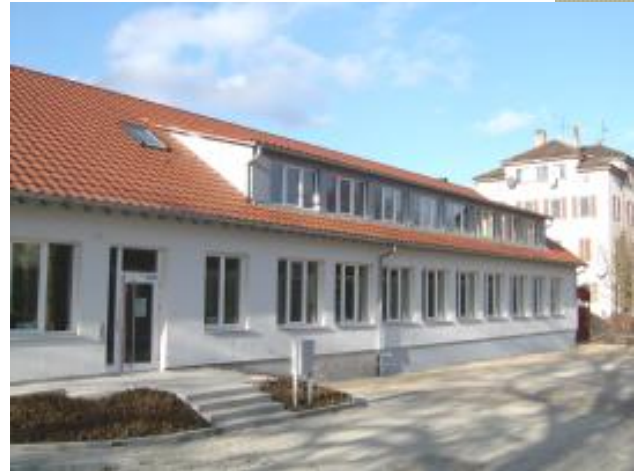
**Figure 30** Office Building Tübingen - View after retrofit

Location	Tübingen / Germany	
Location Type	inner city	
HDD	6,089	
CDD	406	
Year of Construction	1954	
Year of Retrofit	2003	
Historic Preservation	neighborhood	
Building Use / Type	office / detached	
Orientation	E-W	
No. of Floors	before	after
	1	1 + 1
Cond. Usable Area (m <sup>2</sup> )	833	
Construct. Cost (€/m <sup>2</sup> )	972

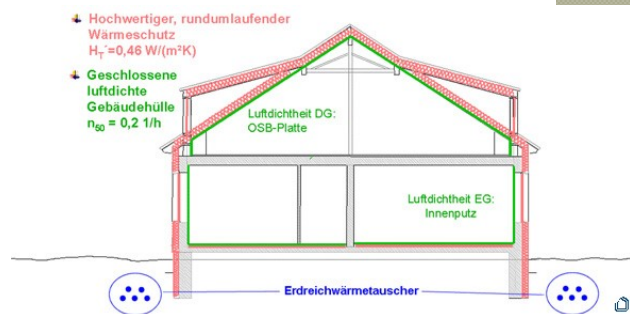
**Figure 29** Office Building Tübingen - Section after renovation

before	after
Walls – Ground Floor	<b>1.500</b>	<b>0.136</b>
Roof	<b>1.700</b>	<b>0.138</b>
Floor / Slab	<b>2.500</b>	<b>0.350</b>
Windows	<b>2.5</b>	<b>0.8</b>
Infiltration Rate (ACH at n50)		<b>0.2</b>

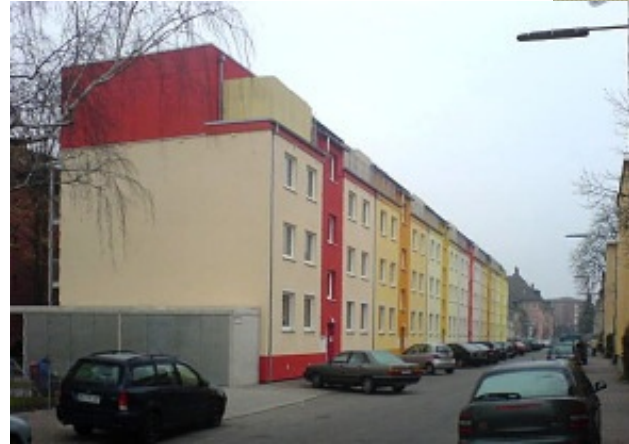
Figure 32 Tevesstrasse Block 1 - View after retrofit

Location	Frankfurt a.M. / Germany	
Location Type	inner city	
HDD	5,515	
CDD	513	
Year of Construction	1951	
Year of Retrofit	2005 – 2006	
Historic Preservation	none	
Building Use / Type	residential / attach. 1 side	
Orientation	NW-SE	
No. of Floors	before	after
	3	3 + 1
Cond. Usable Area (m <sup>2</sup> )	1,851	2,244
Construct. Cost (€/m <sup>2</sup> )		1,350

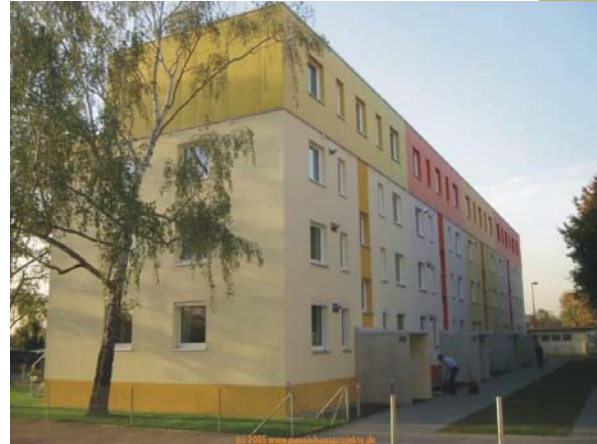
Figure 34 Tevesstrasse Block 2 - Front View after retrofit

Location	Frankfurt a.M. / Germany	
Location Type	inner city	
HDD	5,515	
CDD	513	
Year of Construction	1951	
Year of Retrofit	2005 – 2006	
Historic Preservation	none	
Building Use / Type	residential / detached	
Orientation	NE-SW	
No. of Floors	before	after
	3	3 + 1
Cond. Usable Area (m <sup>2</sup> )	1,123	1,350
Construct. Cost (€/m <sup>2</sup> )		1,350

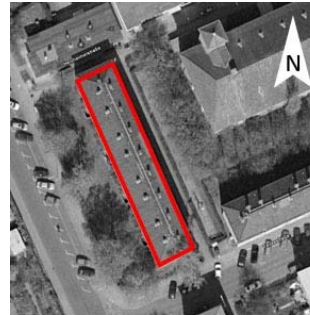
Figure 33 Tevesstrasse Block 2 - Back View after retrofit

before	after
Walls	1.300	0.122
Roof	1.600	0.106
Floor / Slab	1.100	0.177
Windows	1.5	0.87
Infiltration Rate (ACH at n50)	4.2	0.5

type	location	thickness (mm)	conductivity (W/mK)
Walls	EPS (Neopor)	exterior	260	0.035
Roof	Cellulose	cavity	400	0.040
Floor / Slab	PU foam	interior + exterior	40 +80	0.025
Windows	triple	replacement	PVC insulated

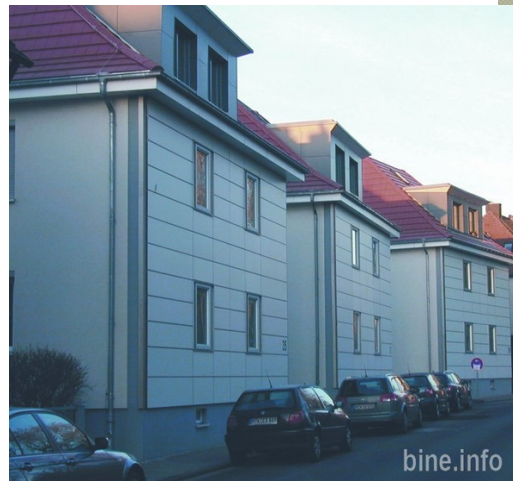
Figure 36 Wilhelmstrasse Hofheim - View after retrofit

Location	Hofheim / Germany	
Location Type	suburb	
HDD	5,515	
CDD	513	
Year of Construction	1927	
Year of Retrofit	2006	
Historic Preservation	none	
Building Use / Type	residential / detached	
Orientation	NE-SW	
No. of Floors	before	after
	2	2 + 1
Cond. Usable Area (m <sup>2</sup> )	273	
Construct. Cost (€/m <sup>2</sup> )	1,039

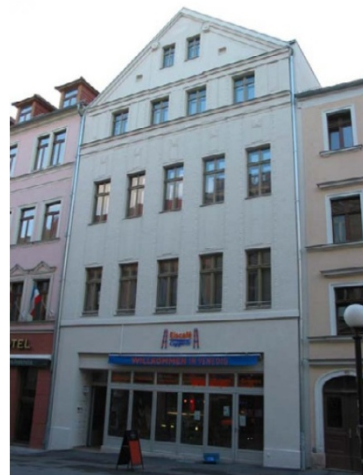
Figure 58. Bautznerstrasse 11 Zittau - after renovation

Location	Zittau / Germany	
Location Type	suburb	
HDD	6,313	
CDD	363	
Year of Construction	1880 – 1990	
Year of Retrofit	2004	
Historic Preservation	wall (street, outside)	roof (outside)
Building Use / Type	residential / attach. 2 sides	
Orientation	E-W	
No. of Floors	before	after
	4 + 1	4 + 1
Cond. Usable Area (m <sup>2</sup> )	1200	1247
Construct. Cost (€/m <sup>2</sup> )

before	after
Walls – Street Façade	1.510	0.500
Walls – Back Façade	1.500	0.380
Walls – Average (rough)	1.503	0.409
Roof – Gable Roof (front)	1.100	0.240
Roof – Flat Roof (back)	1.100	0.240
Floor / Slab	1.110	0.660
Windows	2.50	1.00
Infiltration Rate (ACH at n50)		3.4

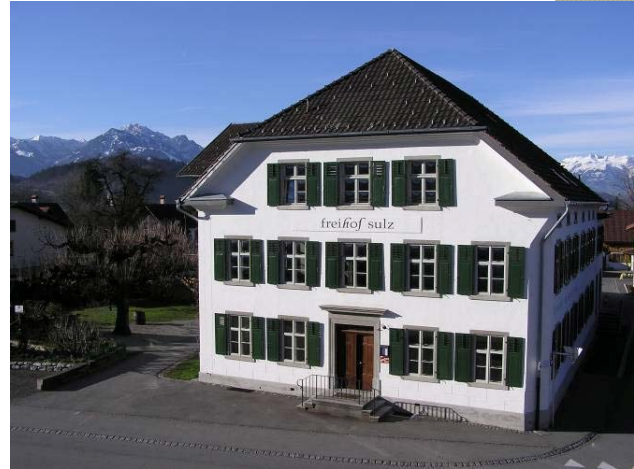
Figure 62. Freihof Sulz Exterior Image – after renovation

type	location	thickness (mm)	conductivity (W/mK)
Walls – AW02 (84%)	<b>wood fiber board</b>	interior	<b>60</b>	<b>0.042</b>
Roof – AD01 (slab)	<b>flax fiber board</b>	cavity	<b>310</b>	<b>0.042</b>
Roof – FD01 (flat roof)	<b>flax fiber/wood fiber</b>	cavity / exterior	<b>250 / 40</b>	<b>0.042</b>
Floor / Slab KD01 (75%)	<b>wood fibers</b>	interior	<b>100</b>	<b>0.042</b>
Floor / Slab KD02 (25%)	<b>EPS</b>	exterior	<b>300</b>	<b>0.060</b>
Windows	<b>single</b>	existing - refurbished	<b>wood</b>

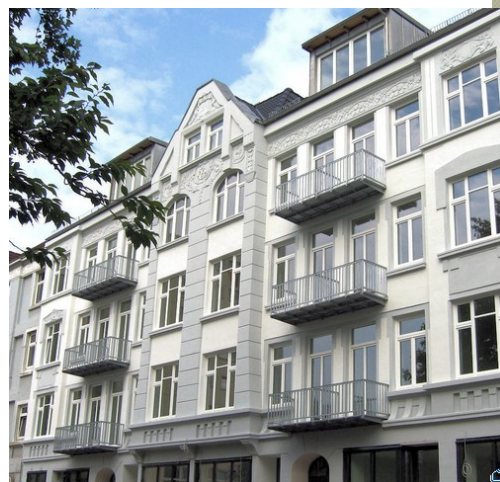
Figure 64 Kleine Freiheit - View after retrofit

type	location	thickness (mm)	conductivity (W/mK)
Walls – Street Façade	Calcium Silicate	interior	50	0.050
Walls – Back Façade	Mineral Fiber	exterior	160	0.035
Roof – Tilted Roof (32%)	Min. Fiber & Foam	cavity	190	0.040
Roof – Flat Roof (27%)	Mineral Fiber	cavity	280	0.040
Slab – on basement (41%)	Min. Fiber / EPS	interior / exterior	85 / 65	0.035 / 0.040
Slab – on grade (29%)	Min. Fiber / EPS	interior	30 / 180	0.040
Windows	double	replacement	wood

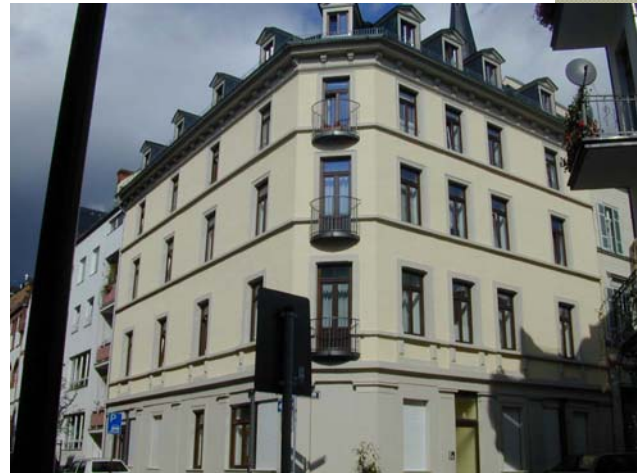
Figure 66 Lehrstrasse 2 - View after retrofit

type	location	thickness (mm)	conductivity (W/mK)
Walls – Street Façade	EPS	interior	55	0.035
Walls – Back Façade	EPS	exterior	120	0.035
Roof	EPS / puddled clay	interior / cavity	110	0.035
Floor / Slab	EPS / fermacell	interior	40 / 20	0.035 / 0.050
Windows	triple	replacement	wood

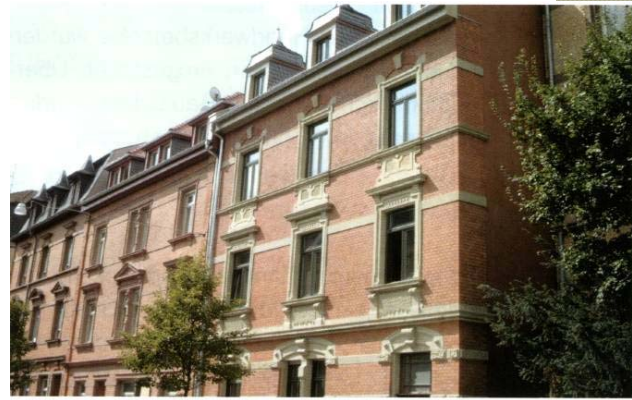
Figure 67 Limburgstrasse - View after retrofit

Location	Ludwigshafen / Germany	
Location Type	inner city	
HDD	5,090	
CDD	666	
Year of Construction	1900	
Year of Retrofit	2004	
Historic Preservation	walls (street, outside)	roof (outside)
Building Use / Type	residential / attach. 2 sides	
Orientation	E-W	
No. of Floors	before	after
	4	4
Cond. Usable Area (m <sup>2</sup> )	651	
Construct. Cost (€/m <sup>2</sup> )

before	after
Walls – Front Facade	1.370	0.330
Walls – Back Facade	1.450	0.210
Walls – Average (rough)	1.409	0.257
Roof		0.180
Floor / Slab		1.10
Windows		
Infiltration Rate (ACH at n50)

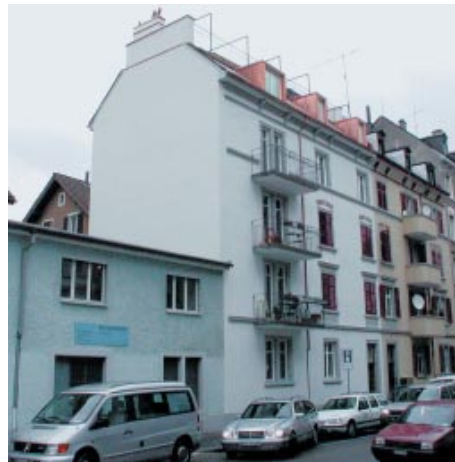
Figure 69 Magnusstrasse - View after retrofit

Location	Ludwigshafen / Germany	
Location Type	inner city	
HDD	6,188	
CDD	444	
Year of Construction	1894	
Year of Retrofit	2001	
Historic Preservation	walls (street, outside)	roof (outside)
Building Use / Type	residential / attached 1 side	
Orientation	NW-SE	
No. of Floors	before	after
	4 + 1	4 + 1
Cond. Usable Area (m <sup>2</sup> )	475	475
Construct. Cost (€/m <sup>2</sup> )

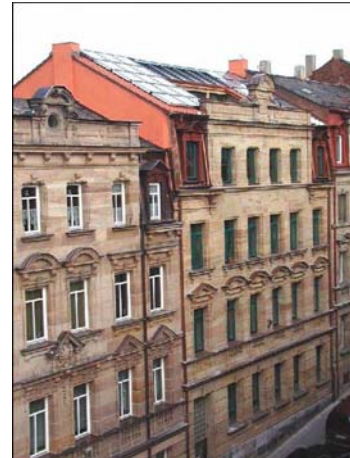
Figure 72 Mathildenstrasse - View after retrofit

Location	Fürth / Germany	
Location Type	inner city	
HDD	6,441	
CDD	382	
Year of Construction	1890	
Year of Retrofit	2002	
Historic Preservation	walls (street, outside)	roof (outside)
Building Use / Type	residential / attach. 2 sides	
Orientation	N-S	
No. of Floors	before	after
	4	4
Cond. Usable Area (m <sup>2</sup> )	404	520
Construct. Cost (€/m <sup>2</sup> )		1,078

before	after
Walls – Front Facade	1.980	0.450
Walls – Back Facade	1.300	0.150
Walls – Average (rough)	1.570	0.225
Roof	1.050	0.100
Floor / Slab	0.870	0.250
Windows	2.80	0.80
Infiltration Rate (ACH at n50)

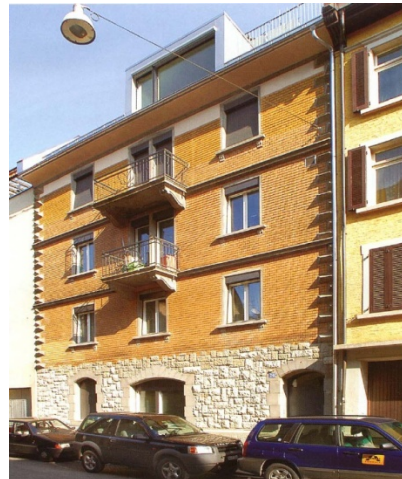
Figure 73 Nietengasse - View after retrofit

Location	Zürich / Switzerland	
Location Type	inner city	
HDD	6,188	
CDD	444	
Year of Construction	1907	
Year of Retrofit	2002	
Historic Preservation	walls (street, outside)	roof (outside)
Building Use / Type	residential / attach. 2 sides	
Orientation	NW-SE	
No. of Floors	before	after
	4 + 1	4 + 1
Cond. Usable Area (m <sup>2</sup> )	574	
Construct. Cost (€/m <sup>2</sup> )

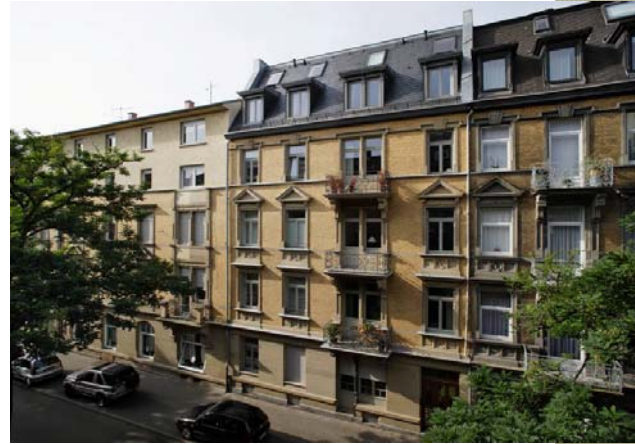
Figure 75 Rheinhäuserstrasse - View after retrofit

type	location	thickness (mm)	conductivity (W/mK)
Walls	Mineral Wool	interior	80	0.035
Roof	Mineral Wool	cavity	200	0.035
Floor / Slab	EPS	exterior	100	0.035
Windows	double	replacement	wood

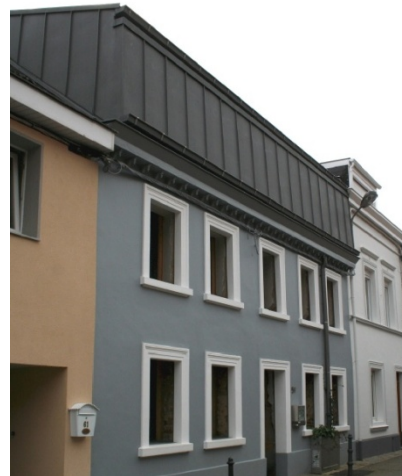
Figure 77 Rowhouse Henz-Noirfalise - View after retrofit

Location	Eupen / Belgium	
Location Type	inner city	
HDD	5,720	
CDD	272	
Year of Construction	1850	
Year of Retrofit	2006	
Historic Preservation	walls (street, outside)	
Building Use / Type	residential / attach. 2 sides	
Orientation	N-S	
No. of Floors	before	after
	2 + 1	2 + 1
Cond. Usable Area (m <sup>2</sup> )	130	180
Construct. Cost (€/m <sup>2</sup> )	951

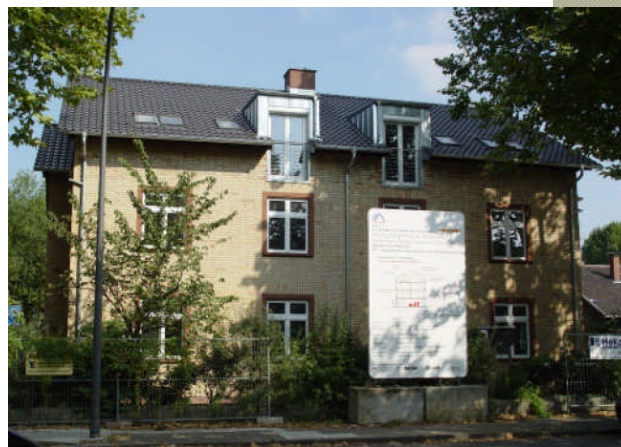
Figure 80 Sodastrasse 40 - View after retrofit

Location	Ludwigshafen / Germany	
Location Type	suburb	
HDD	5,090	
CDD	666	
Year of Construction	1892	
Year of Retrofit	2005	
Historic Preservation	walls + roof (outside)	
Building Use / Type	residential / detached	
Orientation	NE-SW	
No. of Floors	before	after
	2 + 1	2 + 1
Cond. Usable Area (m <sup>2</sup> )	215	
Construct. Cost (€/m <sup>2</sup> )

before	after
Walls	1.548	0.303
Roof	1.314	0.087
Floor / Slab	2.276	0.272
Windows		1.17
Infiltration Rate (ACH at n50)		0.7

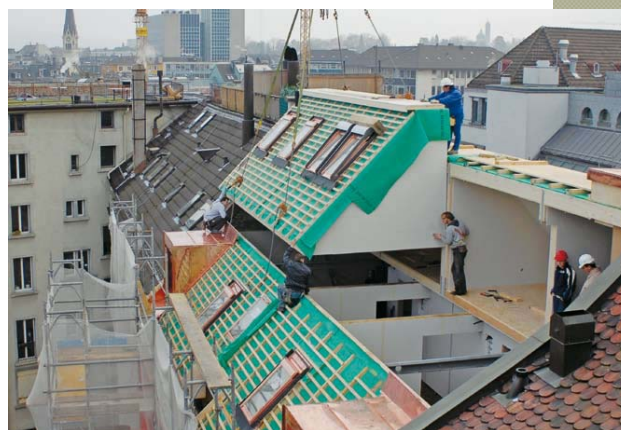
Figure 84 Wengistrasse - Installation of the prefabricated roof sections

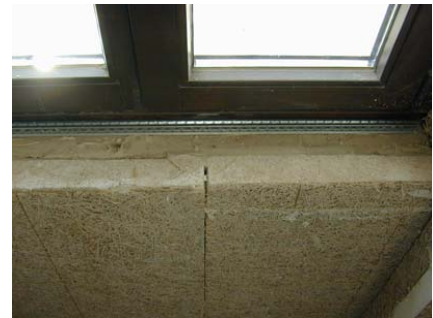
**Figure 105** EPS panels with wood fibre support layer for plaster – Lehrstrasse 2 Wiesbaden (Loga, et al., 2003)

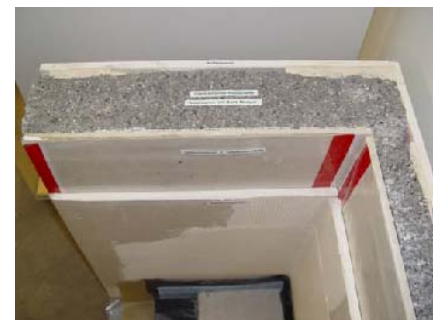
**Figure 106** EPS panels with plasterboard later – Sodastrasse 40 Ludwigshafen (Vogelsang, 2005)

- c. ***The use of composite insulation panels*** which have a layer of insulation glued to a layer of plasterboard (towards the interior of the building). The plasterboard panels need to be taped together using a resistant tape. Such a solution was used in the case of the Sodastrasse project in Ludwigshafen. The insulation material in that case was Neopor (EPS). A second layer of plasterboard was used for the interior finish.

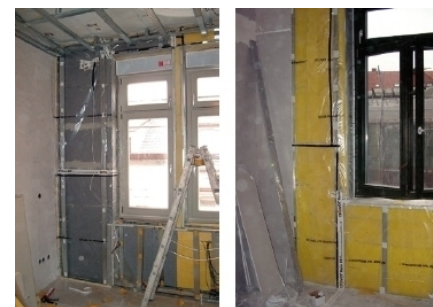
**Figure 107** Air tight foil on the interior of the insulation – Limburgstrasse Ludwigshafen (Bergmeister, et al., 2008)

- d. ***The Application of an air tight Foil*** on the interior of the insulation. The foil has to be taped to the other components of the building. Special care must be given to the areas around window openings. This method was used in the case of the Limburgstrasse project in Ludwigshafen. In that case, two types of insulation materials were used for comparison purposes (EPS and Mineral Fiber).

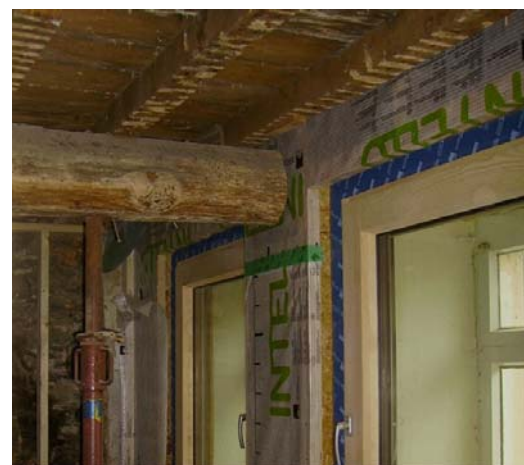
**Figure 110** Disconnected beam and continuous internal insulation layer - Rowhouse Hens-Noirfalise in Eupen (Belgian Science Policy)

incurred by thermal bridging (Feist, et al., 2001). This opinion corresponds to the findings of the present report, which has found a much weaker correlation between performance and insulation values when comparing historic retrofits with interior insulation to non historic retrofits with exterior insulation.

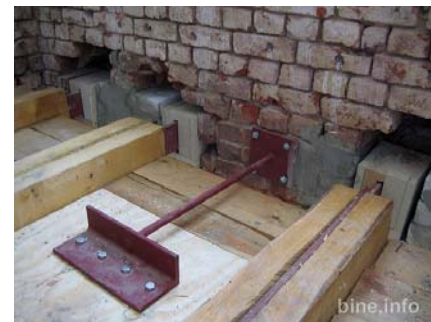
**Figure 124** Beam ends are disconnected from the wall – beams are held in place by steel beams inside the wall – insulation layer is continuous and thermal bridges area almost eliminated – Kleine Freiheit Hamburg (Forschungszentrum Julich,

- b. *The severing of the connection to the external wall.* – In this case the beams can be fitted with a steel connection which will connect them to the original load bearing wall (the original wall holds the load) such as in the case of the Kleine Freiheit project in Hamburg. Another option requires a secondary supporting structure within the thermal envelope to support the beams (Villa Pobershau and Rowhouse Henz-Noirfalise).

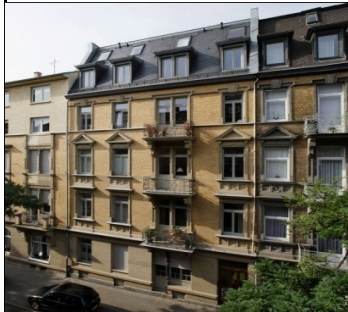
<small>Straßenfassade vor Sanierung</small>

before retrofit	after retrofit	improvement %
Location			
City	Mannheim		
State / Country	Baden Wurtemberg / Germany		
Address	Rheinhäuserstr 6, 68165 Mannheim, Germany		
Location Type	inner city		
Climate			
Climate Zone	4		Ashrae 189.1 (09)
HDD (65 F)	5,090		(degreedays.net)
CDD (65 F)	666		(degreedays.net)
Notes			
Building Details			
Year of Construction	1901		
Year of Retrofit	2007		
Historic Preservation Status	building		
Preservation Constraints Walls	outside		
Preservation Constraints Roof	none		
Building Use	residential		
Building Type	attached 2 sides		
L/I ratio (Length/Width)	1		
Orientation	NE-SW

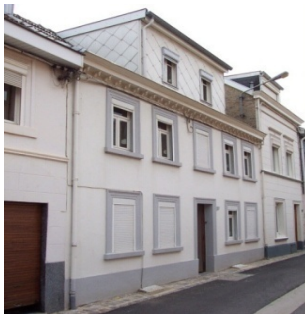
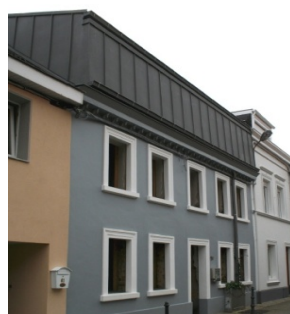
Project Name:	Rowhouse Henz-Noirfalise			
APPENDIX 19

before retrofit	after retrofit	improvement %	
Location				
City	Eupen			
State / Country	Belgium			
Address	Heggenstrasse 59, 4700 Eupen, Belgium			
Location Type	inner city			
Climate				
Climate Zone	5		Ashrae 189.1 (09)	
HDD (65 F)	5,720		(degreedays.net)	
CDD (65 F)	272		(degreedays.net)	
Notes				
Building Details				
Year of Construction	1850			
Year of Retrofit	2006			
Historic Preservation Status	building			
Preservation Constraints Walls	outside			
Preservation Constraints Roof	none			
Building Use	residential			
Building Type	attached 2 sides			
L/I ratio (Length/Width)	1.27			
Orientation	N-S

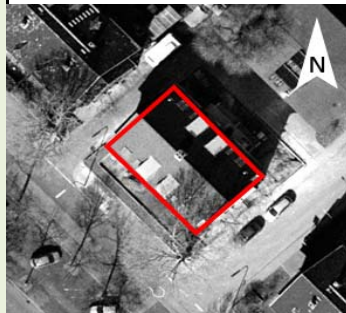
before retrofit	after retrofit	improvement %
Location			
City	Ludwigshafen		
State / Country	Germany		
Address	Sodastrasse 40, Ludwigshafen, Germany		
Location Type	suburb		
Climate			
Climate Zone	4		Ashrae 189.1 (09)
HDD (65 F)	5,090		(degreedays.net)
CDD (65 F)	666		(degreedays.net)
Notes			
Building Details			
Year of Construction	1892		
Year of Retrofit	2005		
Historic Preservation Status	building		
Preservation Constraints Walls	outside		
Preservation Constraints Roof	none		
Building Use	residential		
Building Type	detached		
L/I ratio (Length/Width)	1.35		
Orientation	NE-SW

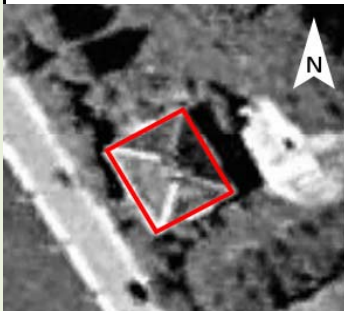
before retrofit	after retrofit	improvement %	
Location				
City	Pobershau			
State / Country	Sachsen / Germany			
Address	AS-Dorfstraße 41, 09496 Pobershau, Germany			
Location Type	inner city/ suburb			
Climate				
Climate Zone	5			Ashrae 189.1 (09)
HDD (65 F)	6,313			(degreedays.net)
CDD (65 F)	363			(degreedays.net)
Notes				
Building Details				
Year of Construction	1882			
Year of Retrofit	2008			
Historic Preservation Status	building			
Preservation Constraints Walls	outside			
Preservation Constraints Roof	outside			
Building Use	residential			
Building Type	detached			
L/I ratio (Length/Width)	1.15			
Orientation	NE-SW
